Flood Control Project Maintenance
2014 Structure Summary Report
Overall Unit and Item Ratings

San Joaquin County Flood Control and Water Conservation District

Duck Creek Diversion Weir And Control Structure

Flood Control Project Maintenance**Unit Cover Sheet****2014 Structure Inspection Results****San Joaquin County Flood Control and Water Conservation District**

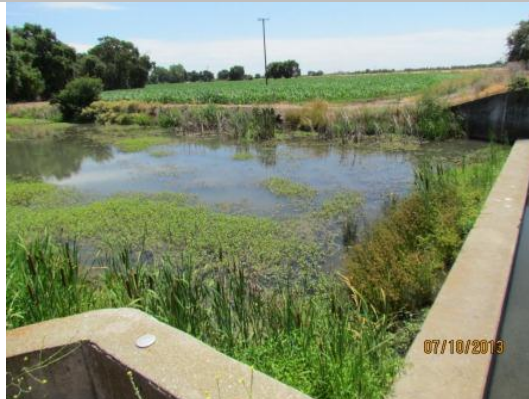
Photo 1 of 1 : ST_2014_NA0017_5_24_20140709_00008.jpg

LM Start	0.00	Rating **	N	Issue No.	24
LM End	0.00	Issue Type +	Ma	Location *	
Category	Structures & Concrete Lined Channels	GPS Latitude/Longitude			
		Start		End	
Item	Photo Documentation	37.938383 °		37.938383 °	
		-120.990133 °		-120.990133 °	
DWR ID	DWR_NA0017_5_t_2013_24				
Action/Comments					
Inspector Comments: Duck Creek Diversion Structure works as a control weir for Duck Creek and also diverts the overflow of the channel to Duck Creek Diversion channel which connects with Little John Creek.

View of the Duck Creek Diversion Weir.

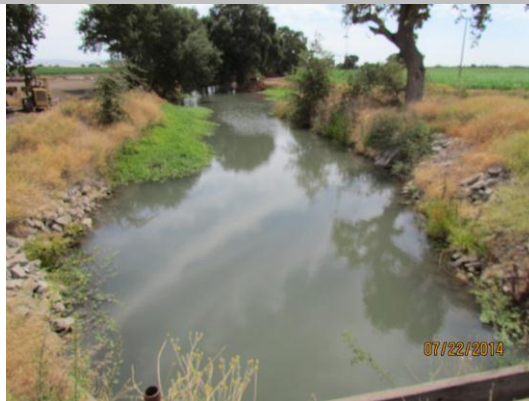
Photo 1 of 2 : ST_2014_NA0017_5_5_20140731_00010.jpg

LM Start	0.00	Rating **	A	Issue No.	5
LM End	0.00	Issue Type +	Ma	Location *	
Category	Structures & Concrete Lined Channels			GPS Latitude/Longitude	
				Start	End
Item	Revetments			37.938383 °	37.938383 °
				-120.990133 °	-120.990133 °
DWR ID	DWR_NA0017_5_t_2012_5				
Action/Comments					
Inspector Comments: Existing riprap protection was properly maintained.

View of the revetments looking upstream of the structure during 2014 inspection.

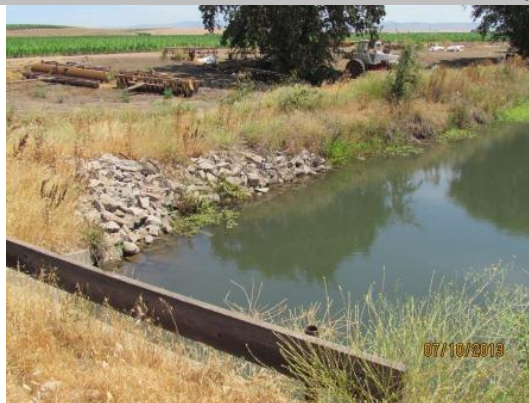
Photo 2 of 2 : ST_2014_NA0017_5_5_20140709_00002.jpg

View of the existing revetments during 2013 inspection.

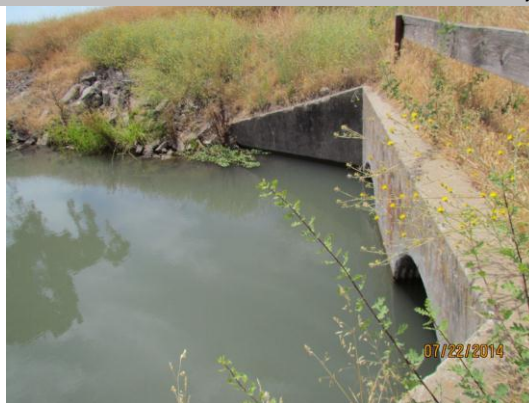
Photo 1 of 2 : ST_2014_NA0017_5_7_20140731_00011.jpg

LM Start	0.00	Rating **	A	Issue No.	7	
LM End	0.00	Issue Type +	Ma	Location *		
Category	Structures & Concrete Lined Channels			GPS Latitude/Longitude		
				Start	End	
Item	Culverts: Inlets / Outlets			37.938383 °	37.938383 °	
				-120.990133 °	-120.990133 °	
DWR ID	DWR_NA0017_5_t_2012_7					
Action/Comments						
Inspector Comments: The culvert's inlet and outlet were free of any debris.

View of the inlet of the culvert.

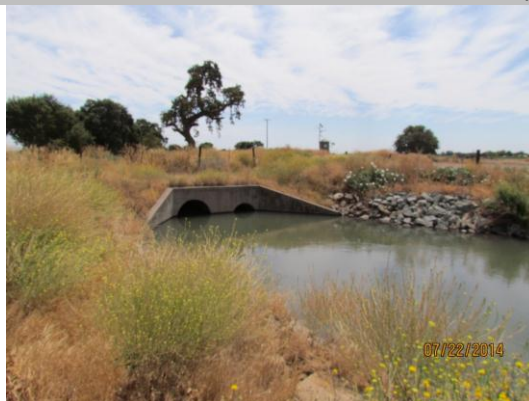
Photo 2 of 2 : ST_2014_NA0017_5_7_20140731_00012.jpg

View of the outlet of the culvert.

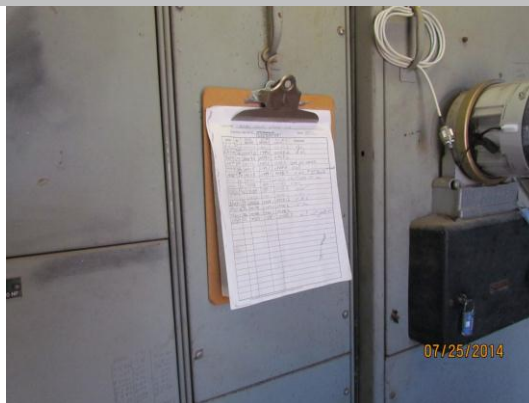
Photo 1 of 1 : ST_2014_NA0017_18_1_20140805_00012.jpg

LM Start	0.00	Rating **	A	Issue No.	1
LM End	0.00	Issue Type +	Ma	Location *	
Category	Pump Stations			GPS Latitude/Longitude	
				Start	End
Item	Operating Log			37.989633 °	37.989633 °
				-121.266933 °	-121.266933 °
DWR ID	DWR_NA0017_18_t_2012_1				
Action/Comments					
Inspector Comments: Operating log was maintained and present at the pumping plant, but it wasn't up to date.

View of the operation log in the plant.

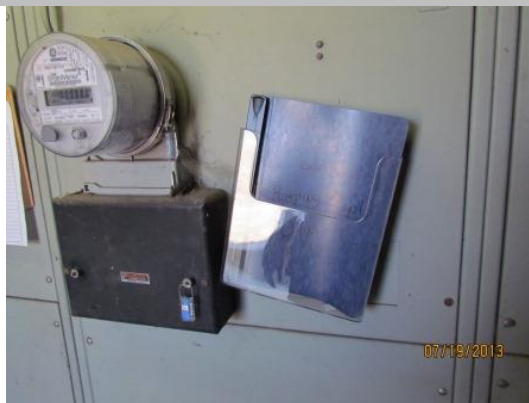
Photo 1 of 1 : ST_2014_NA0017_18_2_20140709_00002.jpg

LM Start	0.00	Rating **	A	Issue No.	2
LM End	0.00	Issue Type +	Ma	Location *	
Category	Pump Stations			GPS Latitude/Longitude	
				Start	End
Item	Operation & Maintenance Manual			37.989633 °	37.989633 °
				-121.266933 °	-121.266933 °
DWR ID	DWR_NA0017_18_t_2012_2				
Action/Comments					
Inspector Comments: The O&M Manual was located next to the operating log.

View of the O&M manual inside the plant.

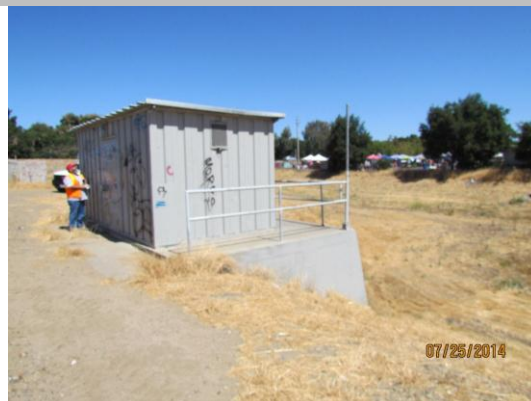
Photo 1 of 1 : ST_2014_NA0017_18_5_20140805_00014.jpg

LM Start	0.00	Rating **	A	Issue No.	5
LM End	0.00	Issue Type +	Ma	Location *	
Category	Pump Stations			GPS Latitude/Longitude	
				Start	End
Item	Safety			37.989633 °	37.989633 °
				-121.266933 °	-121.266933 °
DWR ID	DWR_NA0017_18_t_2012_5				
Action/Comments					
Inspector Comments: There were no safety hazards found around the structure and the guard rails around the structure were in good condition.

View of the guard rails around the plant.

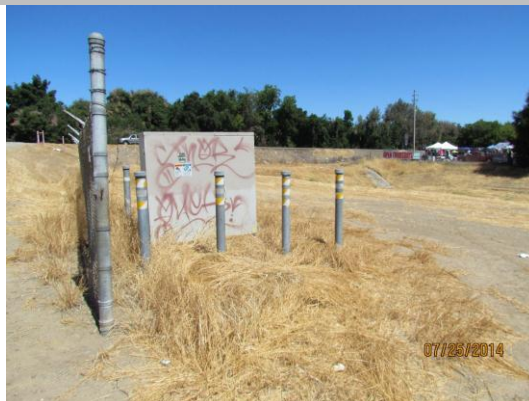
Photo 1 of 1 : ST_2014_NA0017_18_8_20140805_00017.jpg

LM Start	0.00	Rating **	A	Issue No.	8
LM End	0.00	Issue Type +	Ma	Location *	
Category	Pump Stations			GPS Latitude/Longitude	
				Start	End
Item	Power			37.989633 °	37.989633 °
				-121.266933 °	-121.266933 °
DWR ID	DWR_NA0017_18_t_2012_8				
Action/Comments					
Inspector Comments: The power source appeared to be safe and

View of the power source next to the pumping plant.

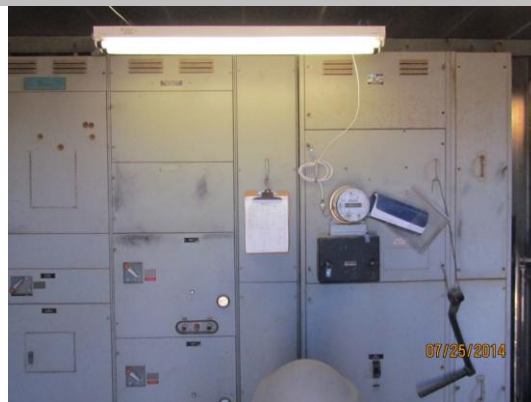
Photo 1 of 1 : ST_2014_NA0017_18_11_20140805_00018.jpg

LM Start	0.00	Rating **	A	Issue No.	11
LM End	0.00	Issue Type +	Ma	Location *	
Category	Pump Stations			GPS Latitude/Longitude	
				Start	End
Item	Pump Control Systems			37.989633 °	37.989633 °
				-121.266933 °	-121.266933 °
DWR ID	DWR_NA0017_18_t_2012_11				
Action/Comments					
Inspector Comments: The pump control systems were maintained properly and appeared to be free of damage.

View of the pump control system inside the plant.

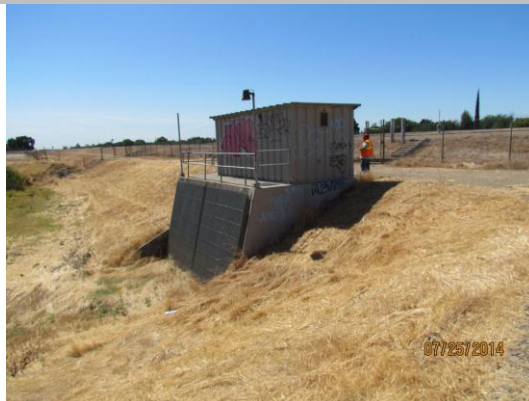
Photo 1 of 1 : ST_2014_NA0017_18_13_20140805_00020.jpg

LM Start	0.00	Rating **	A	Issue No.	13
LM End	0.00	Issue Type +	Ma	Location *	
Category	Pump Stations			GPS Latitude/Longitude	
				Start	End
Item	Trash Racks			37.989633 °	37.989633 °
				-121.266933 °	-121.266933 °
DWR ID	DWR_NA0017_18_t_2012_13				
Action/Comments					
Inspector Comments: Trash Racks were properly maintained and clear of debris.

View of the trash racks.

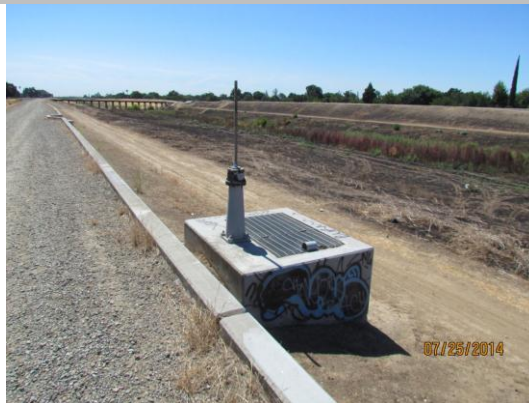
Photo 1 of 1 : ST_2014_NA0017_18_15_20140805_00021.jpg

LM Start	0.00	Rating **	A	Issue No.	15
LM End	0.00	Issue Type +	Ma	Location *	
Category	Pump Stations			GPS Latitude/Longitude	
				Start	End
Item	Sluice / Slide Gates			37.989633 °	37.989633 °
				-121.266933 °	-121.266933 °
DWR ID	DWR_NA0017_18_t_2012_15				
Action/Comments					
Inspector Comments: The slide gate appeared to be in good condition.

View of the slide gate.

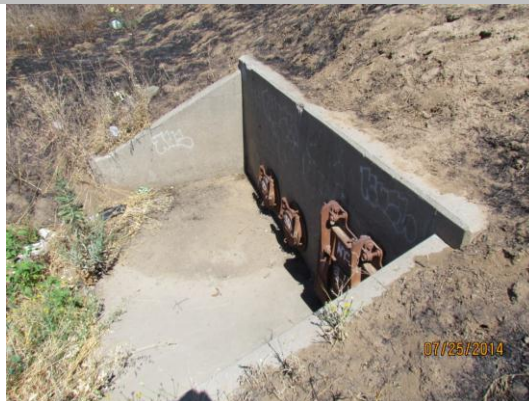
Photo 1 of 1 : ST_2014_NA0017_18_19_20140805_00022.jpg

LM Start	0.00	Rating **	A	Issue No.	19
LM End	0.00	Issue Type +	Ma	Location *	
Category	Pump Stations			GPS Latitude/Longitude	
				Start	End
Item	Flap Gates			37.989633 °	37.989633 °
				-121.266933 °	-121.266933 °
DWR ID	DWR_NA0017_18_t_2012_19				
Action/Comments					
Inspector Comments: The flap gates appeared to be in good working condition.

View of the flap gates.

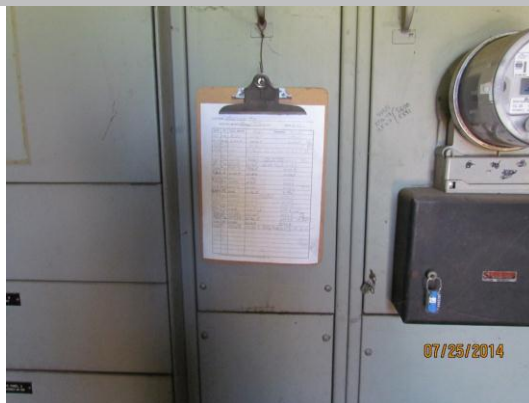
Photo 1 of 1 : ST_2014_NA0017_19_1_20140804_00011.jpg

LM Start	0.00	Rating **	A	Issue No.	1	
LM End	0.00	Issue Type +	Ma	Location *		
Category	Pump Stations			GPS Latitude/Longitude		
				Start	End	
Item	Operating Log			37.982317 °	37.982317 °	
				-121.249433 °	-121.249433 °	
DWR ID	DWR_NA0017_19_t_2012_1					
Action/Comments						
Inspector Comments: Operational log was present at the pump station.

View of the operation log inside the pumping plant.

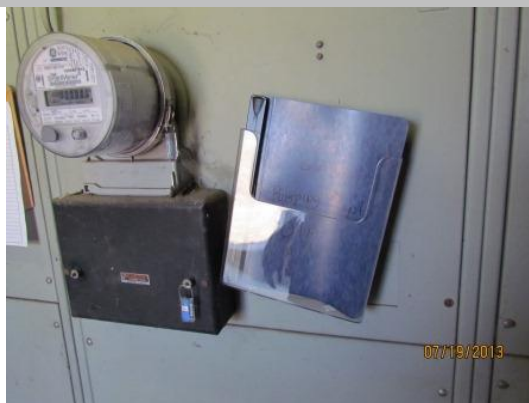
Photo 1 of 1 : ST_2014_NA0017_19_2_20140709_00002.jpg

LM Start	0.00	Rating **	A	Issue No.	2
LM End	0.00	Issue Type +	Ma	Location *	
Category	Pump Stations			GPS Latitude/Longitude	
				Start	End
Item	Operation & Maintenance Manual			37.982317 °	37.982317 °
				-121.249433 °	-121.249433 °
DWR ID	DWR_NA0017_19_t_2012_2				
Action/Comments					
Inspector Comments: O&M Manual was found at the plant next to the operating log during the inspection.

View of the O&M manual inside the pumping plant.

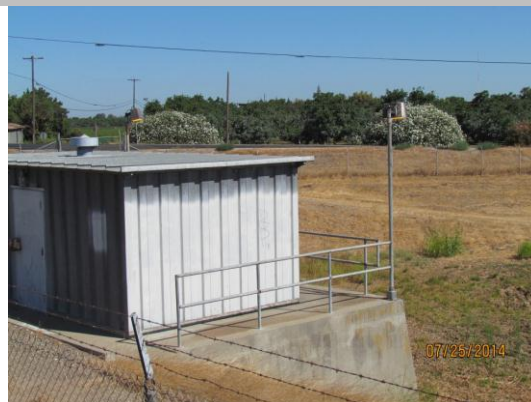
Photo 1 of 1 : ST_2014_NA0017_19_5_20140804_00013.jpg

LM Start	0.00	Rating **	A	Issue No.	5
LM End	0.00	Issue Type +	Ma	Location *	
Category	Pump Stations			GPS Latitude/Longitude	
				Start	End
Item	Safety			37.982317 °	37.982317 °
				-121.249433 °	-121.249433 °
DWR ID	DWR_NA0017_19_t_2012_5				
Action/Comments					
Inspector Comments: No safety hazard was found around the structure. All hand rails were in working condition.

View of the hand rails around the pumping plant.

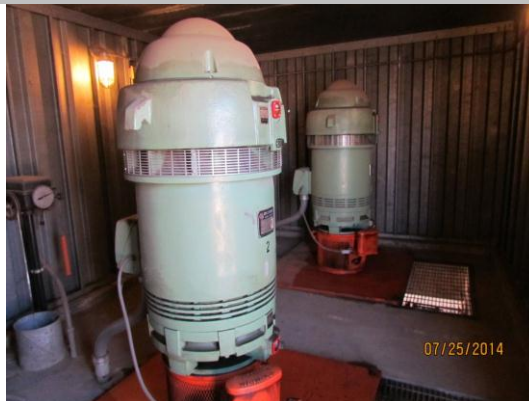
Photo 1 of 1 : ST_2014_NA0017_19_7_20140804_00014.jpg

LM Start	0.00	Rating **	A	Issue No.	7
LM End	0.00	Issue Type +	Ma	Location *	
Category	Pump Stations			GPS Latitude/Longitude	
				Start	End
Item	Pumps			37.982317 °	37.982317 °
				-121.249433 °	-121.249433 °
DWR ID	DWR_NA0017_19_t_2012_7				
Action/Comments					
Inspector Comments: The pumps appeared to be well maintained and lubricated properly and the pumping system was tested periodically.

View of the pumps inside the pumping plant.

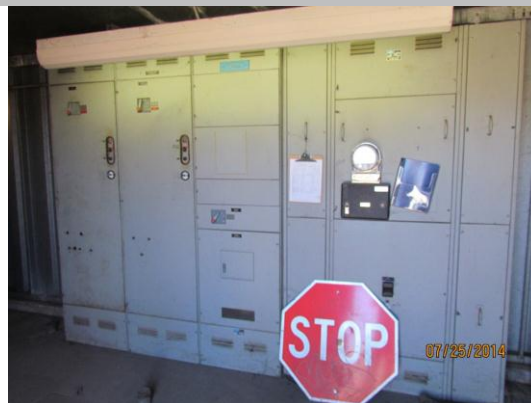
Photo 1 of 1 : ST_2014_NA0017_19_11_20140804_00015.jpg

LM Start	0.00	Rating **	A	Issue No.	11
LM End	0.00	Issue Type +	Ma	Location *	
Category	Pump Stations			GPS Latitude/Longitude	
				Start	End
Item	Pump Control Systems			37.982317 °	37.982317 °
				-121.249433 °	-121.249433 °
DWR ID	DWR_NA0017_19_t_2012_11				
Action/Comments					
Inspector Comments: The pump control system was maintained to be free of corrosion or any damage.

View of the power control system.

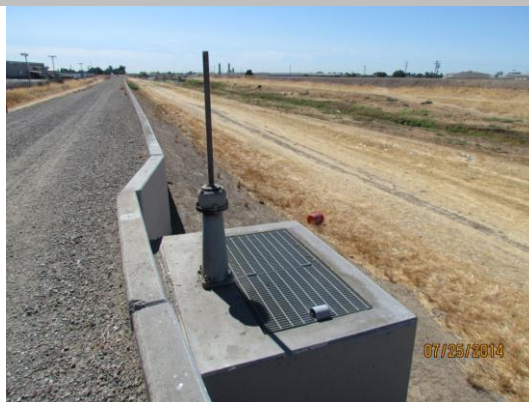
Photo 1 of 1 : ST_2014_NA0017_19_15_20140804_00018.jpg

LM Start	0.00	Rating **	A	Issue No.	15
LM End	0.00	Issue Type +	Ma	Location *	
Category	Pump Stations			GPS Latitude/Longitude	
				Start	End
Item	Sluice / Slide Gates			37.982317 °	37.982317 °
				-121.249433 °	-121.249433 °
DWR ID	DWR_NA0017_19_t_2012_15				
Action/Comments					
Inspector Comments: The slide gate appeared to be operational.

View of the slide gate.

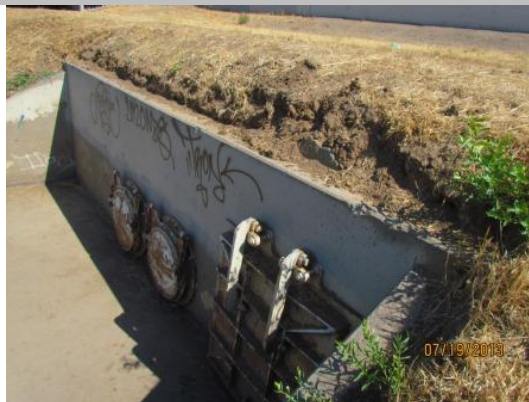
Photo 1 of 1 : ST_2014_NA0017_19_19_20140709_00010.jpg

LM Start	0.00	Rating **	A	Issue No.	19
LM End	0.00	Issue Type +	Ma	Location *	
Category	Pump Stations			GPS Latitude/Longitude	
				Start	End
Item	Flap Gates			37.982317 °	37.982317 °
				-121.249433 °	-121.249433 °
DWR ID	DWR_NA0017_19_t_2012_19				
Action/Comments					
Inspector Comments: Flap gates were in good condition and showed no damage.

View of the flap gates.

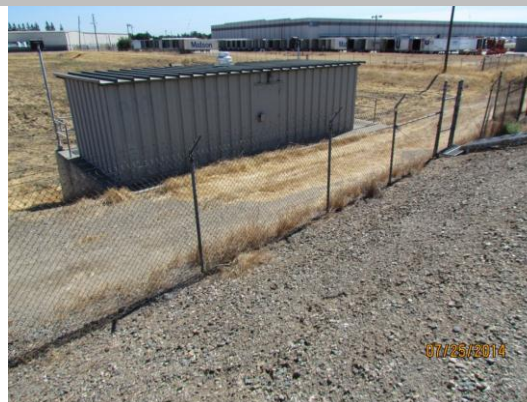
Photo 1 of 1 : ST_2014_NA0017_19_21_20140804_00019.jpg

LM Start	0.00	Rating **	A	Issue No.	21
LM End	0.00	Issue Type +	Ma	Location *	
Category	Pump Stations			GPS Latitude/Longitude	
				Start	End
Item	Security Fencing			37.982317 °	37.982317 °
				-121.249433 °	-121.249433 °
DWR ID	DWR_NA0017_19_t_2012_21				
Action/Comments					
Inspector Comments: Security fencing was in good condition without any damage.

View of the security fencing.

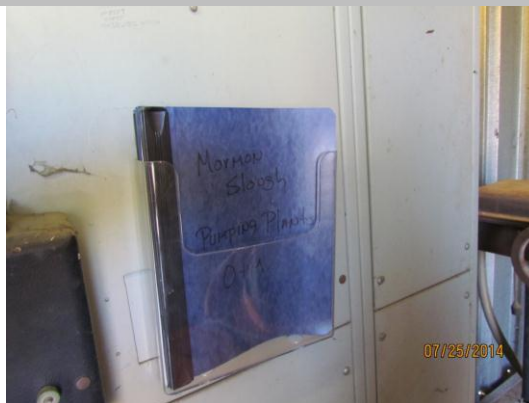
Photo 1 of 1 : ST_2014_NA0017_20_2_20140801_00012.jpg

LM Start	0.00	Rating **	A	Issue No.	2
LM End	0.00	Issue Type +	Ma	Location *	
Category	Pump Stations			GPS Latitude/Longitude	
				Start	End
Item	Operation & Maintenance Manual			37.973983 °	37.973983 °
				-121.229967 °	-121.229967 °
DWR ID	DWR_NA0017_20_t_2012_2				
Action/Comments					
Inspector Comments: The O&M Manual was present at the pumping plant next to the operating log.

View of the O&M manual inside the pumping plant.

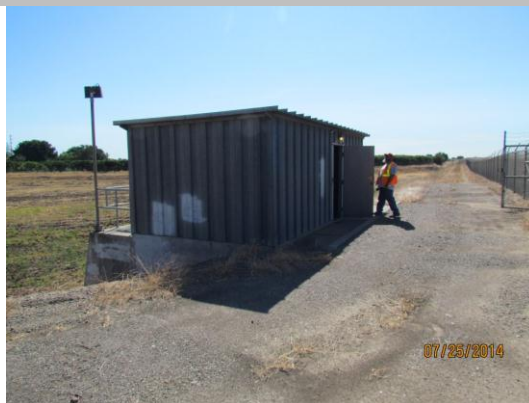
Photo 1 of 1 : ST_2014_NA0017_20_3_20140804_00024.jpg

LM Start	0.00	Rating **	A	Issue No.	3
LM End	0.00	Issue Type +	Ma	Location *	
Category	Pump Stations			GPS Latitude/Longitude	
				Start	End
Item	Plant Building			37.973983 °	37.973983 °
				-121.229967 °	-121.229967 °
DWR ID	DWR_NA0017_20_t_2012_3				
Action/Comments					
Inspector Comments: The plant building appeared to be in good structural condition.

View of the pumping plant.

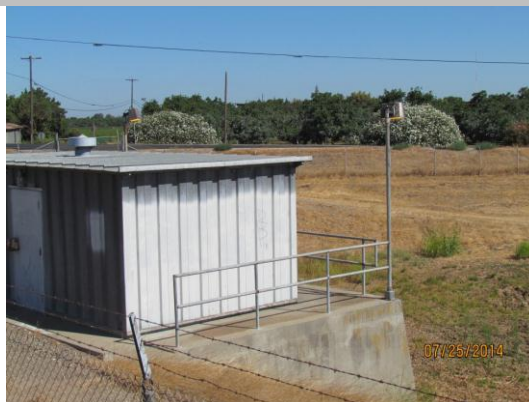
Photo 1 of 1 : ST_2014_NA0017_20_5_20140804_00014.jpg

LM Start	0.00	Rating **	A	Issue No.	5
LM End	0.00	Issue Type +	Ma	Location *	
Category	Pump Stations			GPS Latitude/Longitude	
				Start	End
Item	Safety			37.973983 °	37.973983 °
				-121.229967 °	-121.229967 °
DWR ID	DWR_NA0017_20_t_2012_5				
Action/Comments					
Inspector Comments: No safety hazard was found around the pumping plant and guard rails around the plant were in a good condition.

View of the guard rails around the pumping plant.

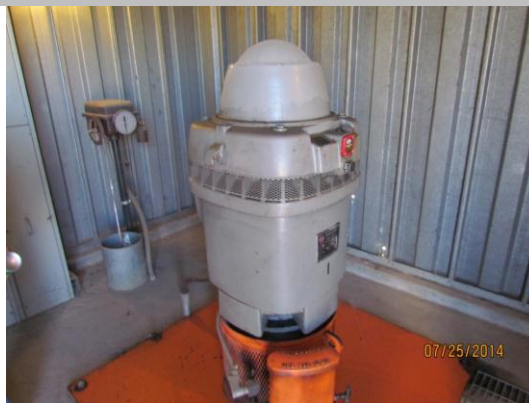
Photo 1 of 2 : ST_2014_NA0017_20_7_20140804_00015.jpg

LM Start	0.00	Rating **	A	Issue No.	7
LM End	0.00	Issue Type +	Ma	Location *	
Category	Pump Stations			GPS Latitude/Longitude	
				Start	End
Item	Pumps			37.973983 °	37.973983 °
				-121.229967 °	-121.229967 °
DWR ID	DWR_NA0017_20_t_2012_7				
Action/Comments					
Inspector Comments: All pumps were appeared to be in good condition and maintained properly.

View of one of the two pumps inside the pumping plant.

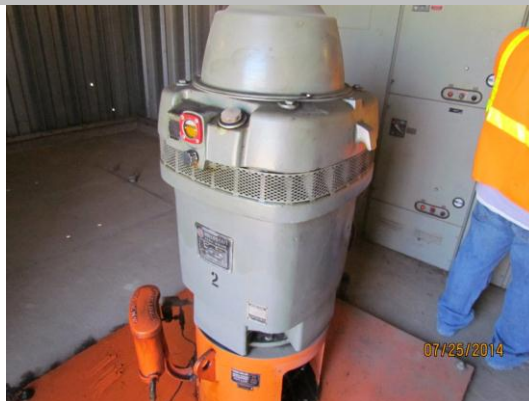
Photo 2 of 2 : ST_2014_NA0017_20_7_20140804_00016.jpg

View of another pump inside the pumping plant.

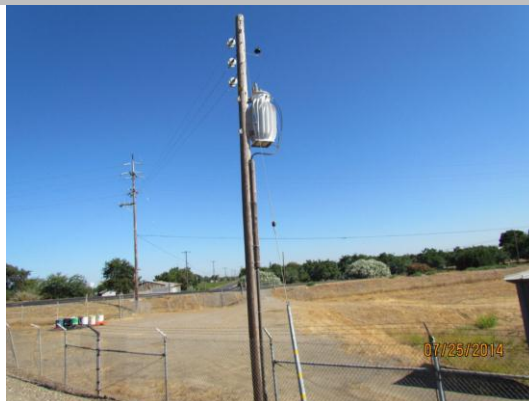
Photo 1 of 1 : ST_2014_NA0017_20_8_20140804_00017.jpg

LM Start	0.00	Rating **	A	Issue No.	8
LM End	0.00	Issue Type +	Ma	Location *	
Category	Pump Stations			GPS Latitude/Longitude	
				Start	End
Item	Power			37.973983 °	37.973983 °
				-121.229967 °	-121.229967 °
DWR ID	DWR_NA0017_20_t_2012_8				
Action/Comments					
Inspector Comments: The power source appeared to be safe and

View of the power source for the pumping plant.

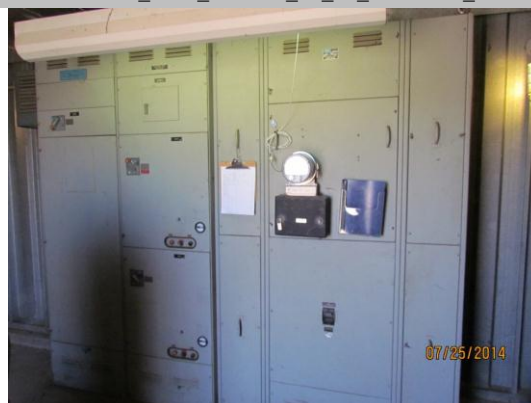
Photo 1 of 1 : ST_2014_NA0017_20_11_20140804_00018.jpg

LM Start	0.00	Rating **	A	Issue No.	11
LM End	0.00	Issue Type +	Ma	Location *	
Category	Pump Stations			GPS Latitude/Longitude	
				Start	End
Item	Pump Control Systems			37.973983 °	37.973983 °
				-121.229967 °	-121.229967 °
DWR ID	DWR_NA0017_20_t_2012_11				
Action/Comments					
Inspector Comments: The pump control system appeared to be operational and free of damage.

View of the power control systems inside the plant.

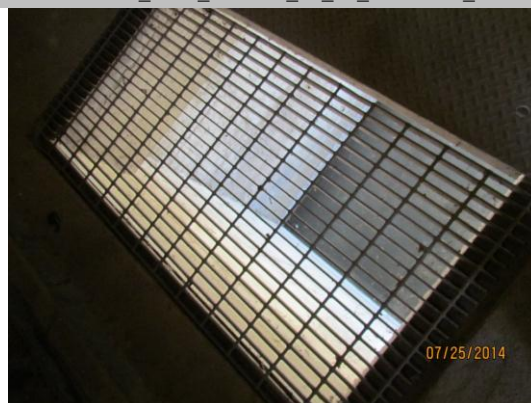
Photo 1 of 1 : ST_2014_NA0017_20_12_20140804_00019.jpg

LM Start	0.00	Rating **	A	Issue No.	12
LM End	0.00	Issue Type +	Ma	Location *	
Category	Pump Stations			GPS Latitude/Longitude	
				Start	End
Item	Sumps/Wet Well			37.973983 °	37.973983 °
				-121.229967 °	-121.229967 °
DWR ID	DWR_NA0017_20_t_2012_12				
Action/Comments					
Inspector Comments: Wet well was clear of any excessive debris.

View of wet well.

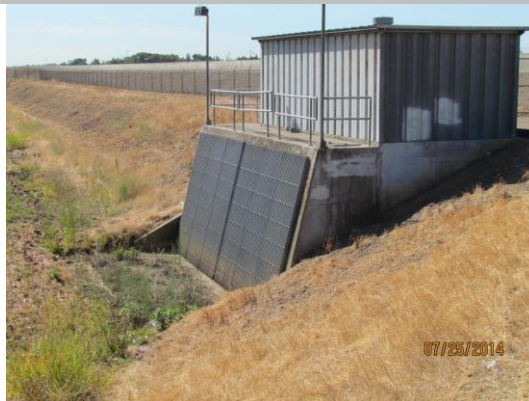
Photo 1 of 1 : ST_2014_NA0017_20_13_20140804_00020.jpg

LM Start	0.00	Rating **	A	Issue No.	13	
LM End	0.00	Issue Type +	Ma	Location *		
Category	Pump Stations			GPS Latitude/Longitude		
				Start	End	
Item	Trash Racks			37.973983 °	37.973983 °	
				-121.229967 °	-121.229967 °	
DWR ID	DWR_NA0017_20_t_2012_13					
Action/Comments						
Inspector Comments: The trash racks were free of any debris.

View of the trash racks.

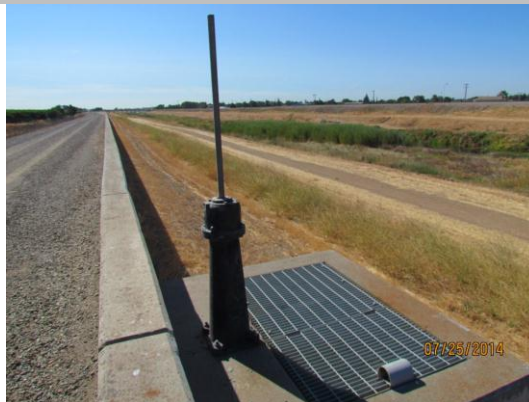
Photo 1 of 1 : ST_2014_NA0017_20_15_20140804_00021.jpg

LM Start	0.00	Rating **	A	Issue No.	15
LM End	0.00	Issue Type +	Ma	Location *	
Category	Pump Stations			GPS Latitude/Longitude	
				Start	End
Item	Sluice / Slide Gates			37.973983 °	37.973983 °
				-121.229967 °	-121.229967 °
DWR ID	DWR_NA0017_20_t_2012_15				
Action/Comments					
Inspector Comments: Slide gates appeared to be free of sediment and obstructions.

View of the slide gate.

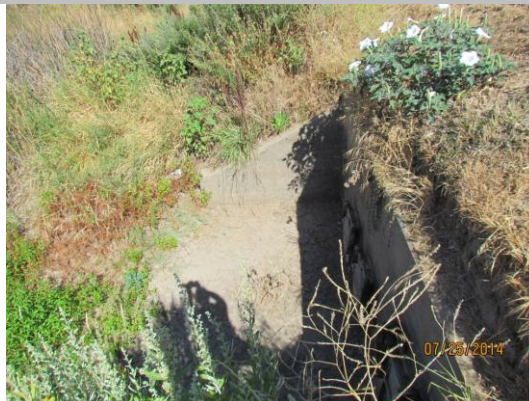
Photo 1 of 1 : ST_2014_NA0017_20_19_20140804_00022.jpg

LM Start	0.00	Rating **	A	Issue No.	19
LM End	0.00	Issue Type +	Ma	Location *	
Category	Pump Stations			GPS Latitude/Longitude	
				Start	End
Item	Flap Gates			37.973983 °	37.973983 °
				-121.229967 °	-121.229967 °
DWR ID	DWR_NA0017_20_t_2012_19				
Action/Comments					
Inspector Comments: Flap gates were appeared to be in good condition.

View of the flap gates.

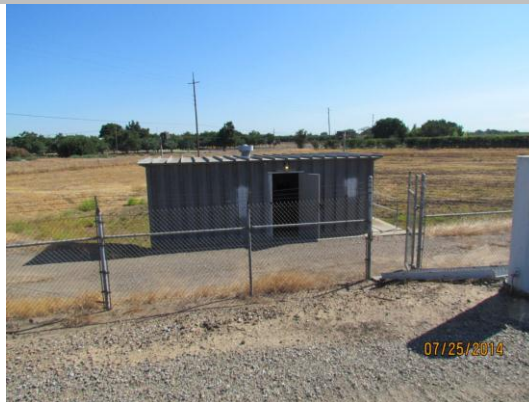
Photo 1 of 1 : ST_2014_NA0017_20_21_20140804_00023.jpg

LM Start	0.00	Rating **	A	Issue No.	21
LM End	0.00	Issue Type +	Ma	Location *	
Category	Pump Stations			GPS Latitude/Longitude	
				Start	End
Item	Security Fencing			37.973983 °	37.973983 °
				-121.229967 °	-121.229967 °
DWR ID	DWR_NA0017_20_t_2012_21				
Action/Comments					
Inspector Comments: Security fencing was undamaged and prevented unauthorized access.

View of the security fencing.
